SCREENING SITE INSPECTION REPORT
FOR
SWIFT AG CHEM--FAIRMONT CITY PLANT
AKA ESTECH BRAND FERTILIZER
U.S. EPA ID: ILD059995423
SS ID: NONE
TDD: F05-8612-077
PAN: FIL0055SB

MAY 2, 1990

SIGNATURE PAGE
FOR
SCREENING SITE INSPECTION REPORT
FOR
SWIFT AG CHEM.--FAIRMONT CITY PLANT
AKA ESTECH BRAND FERTILIZER
U.S. EPA ID: ILD059995423
SS ID: NONE
TDD: F05-8612-077
PAN: FILO055SB

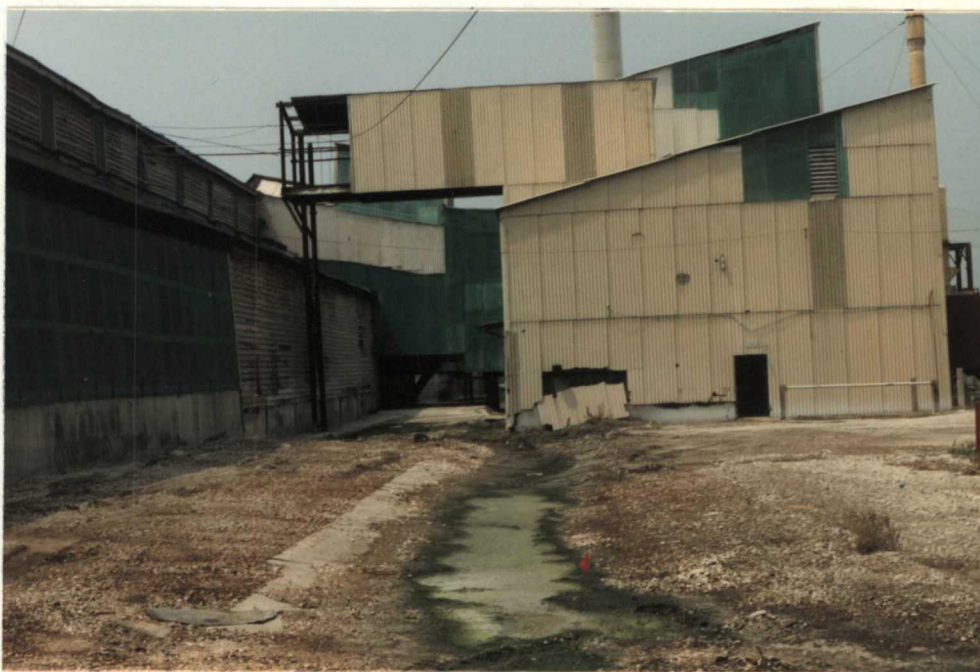
DESCRIPTION: Drainage ditch located on the north side
of the main plant building, building 1A is located
on the right.

Several ditches were observed on-site during the reconnaissance inspection. A ditch containing greenish-tinted standing water was observed adjacent to building #1. This ditch runs from east to west along the north side of building #1, between the tanks and building #1, and then passes through a culvert before exiting the property near the northwest corner of the site.

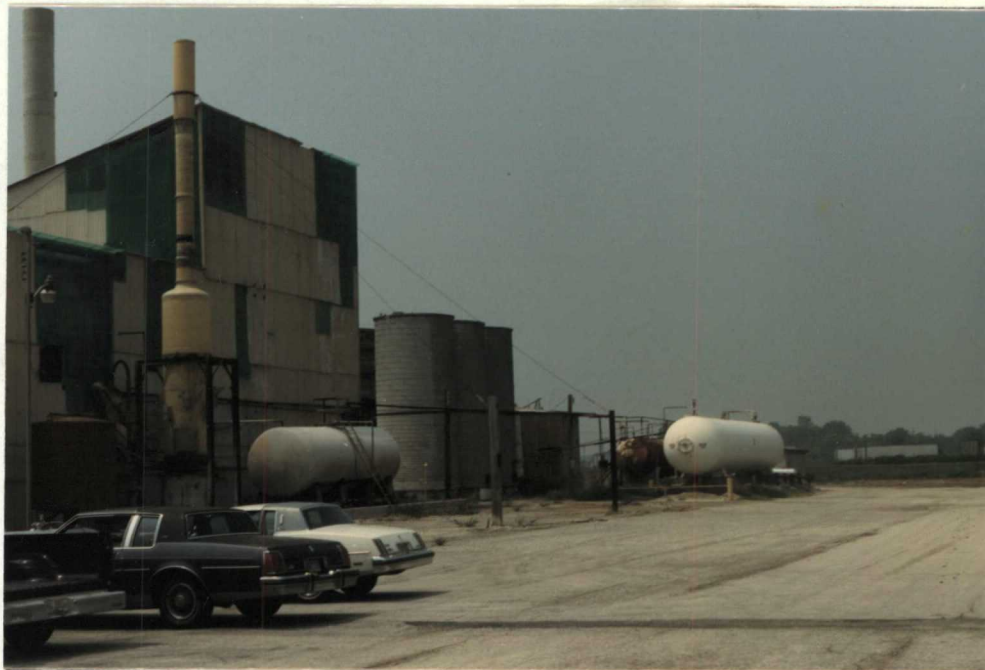
DESCRIPTION: Building 1A, empty anhydrous ammonia and sulfuric acid tanks located to the right, empty silos in the center.

Building #1A is located adjacent to building #1, to the north. A former oil tank (1), now empty, and a 10,000-gallon fuel oil tank (2) are located just north of building #1A. A 30,000-gallon anhydrous ammonia tank (3) and a 12,000-gallon sulfuric acid tank (4) are located at the northwest corner of building #1A, and a water tank (5) is located to the west of the building. The anhydrous ammonia and sulfuric acid tanks were both empty at the time of the SSI.

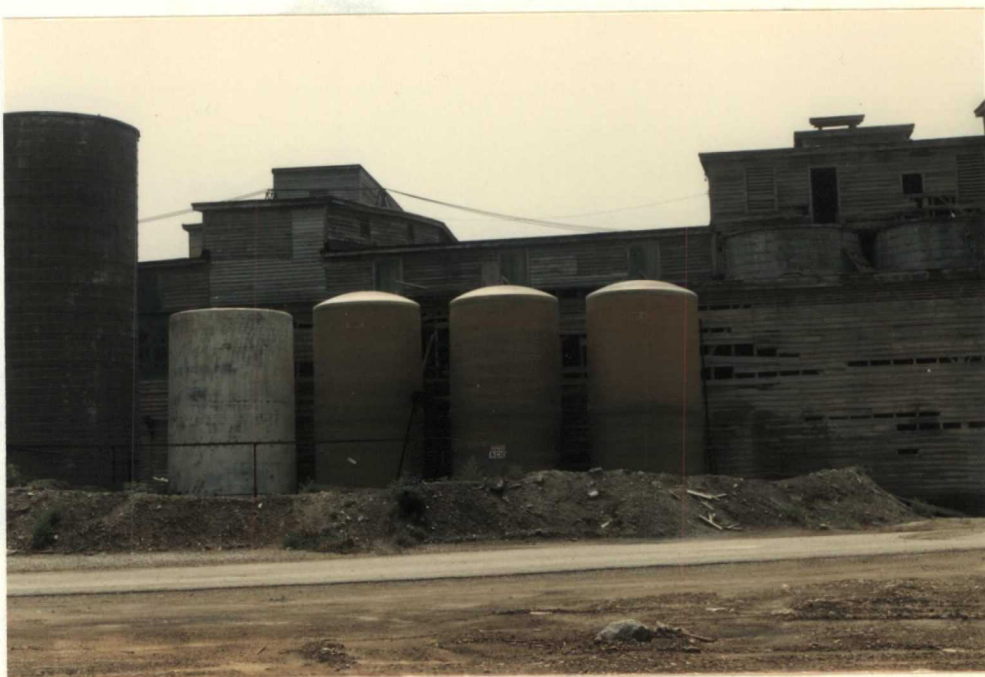
DESCRIPTION: Four tanks located on the north side of the main plant building (tanks 12, 13, 14, 15).

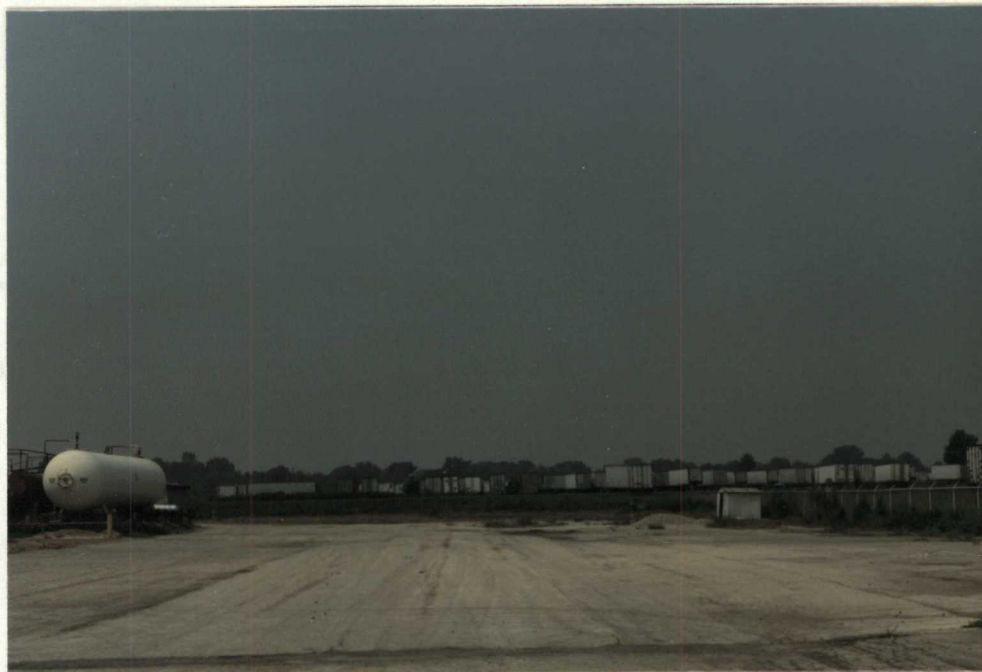
DESCRIPTION: Paved area located north of the main plant building, location of the former settling basin.

The location of the former settling basin is the northwest corner of the site. When use of the settling basin was discontinued, material from this area was excavated and deposited into the old reservoir, located to the west of building #1. The settling basin area was then covered with cinders. FIT observed an area of discolored soil near the location of the former settling basin.

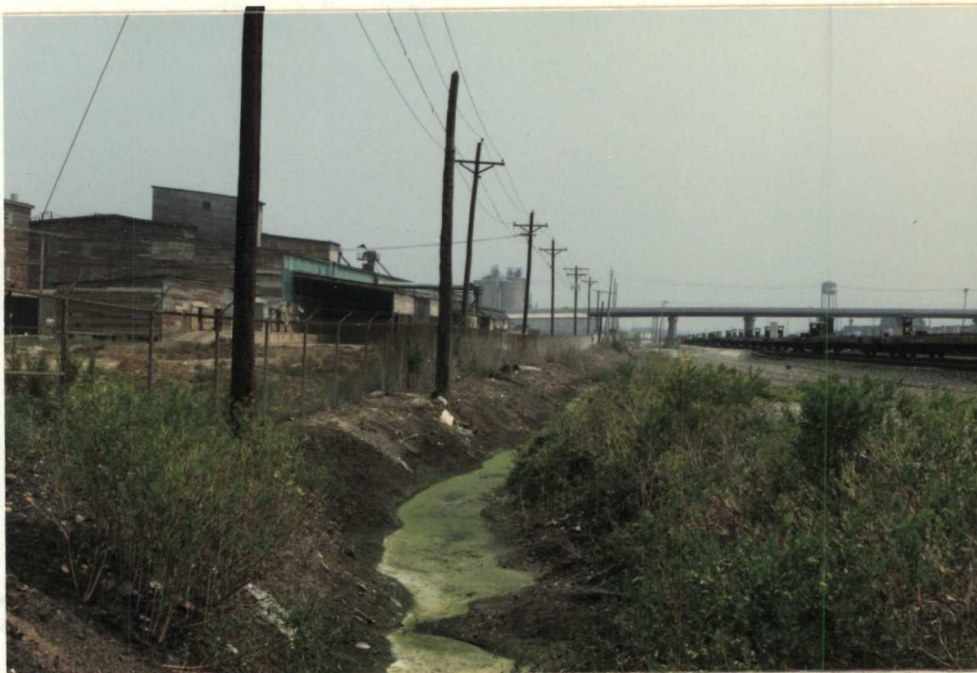
DESCRIPTION: Ditch located adjacent to the site on the south.

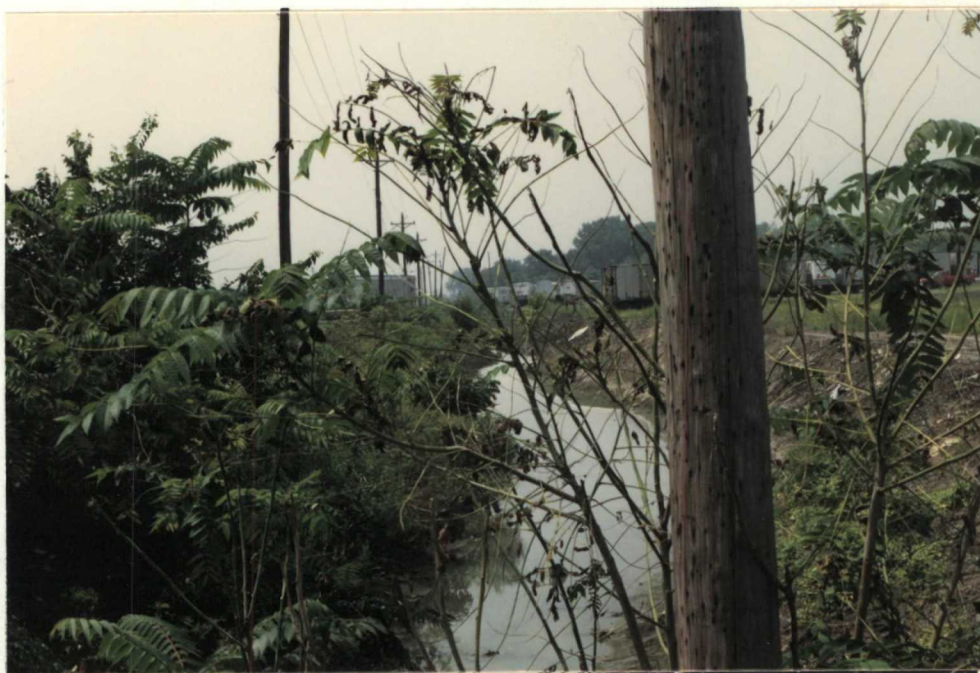
DESCRIPTION: Ditch located adjacent to the site on the north from the northeast corner of the site.

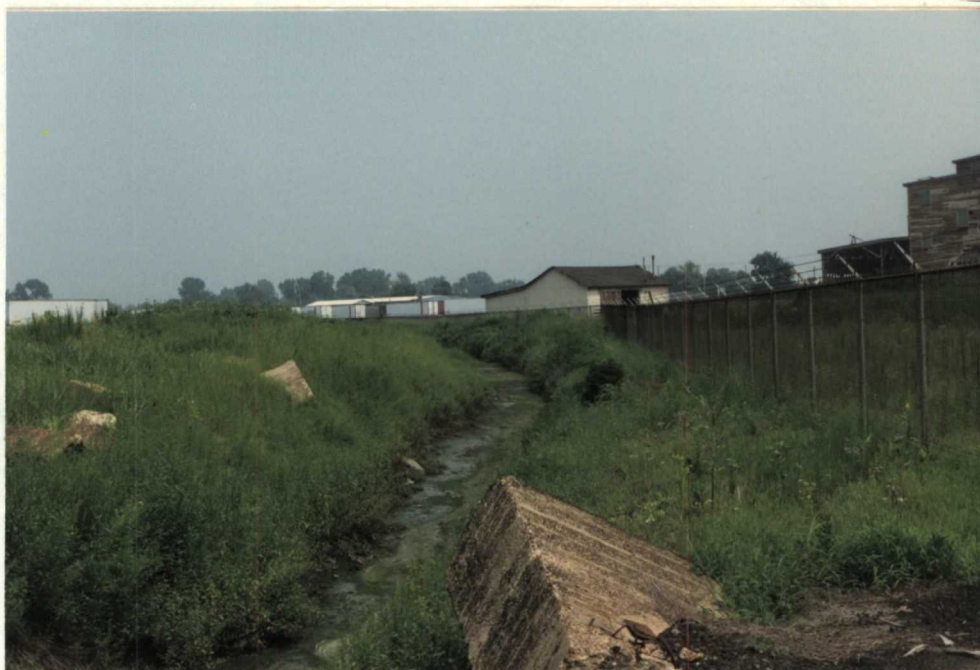
DESCRIPTION: Ditch located adjacent to the site on the
northwest From the southwest corner of the site.

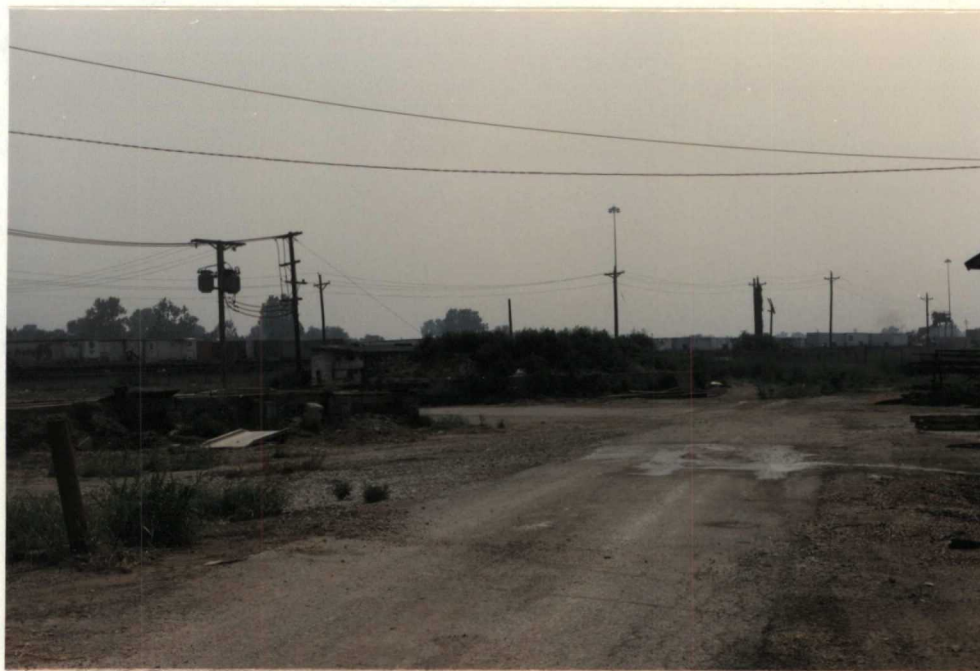
DESCRIPTION: Old reservoir in background, which was
utilized for deposition of scrubber slurry.

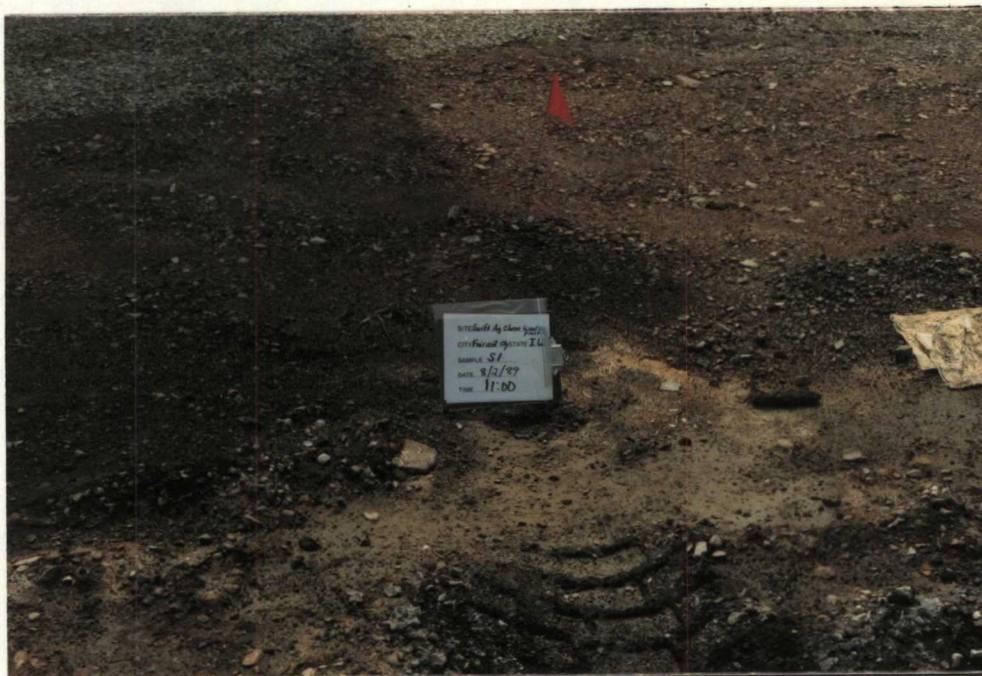
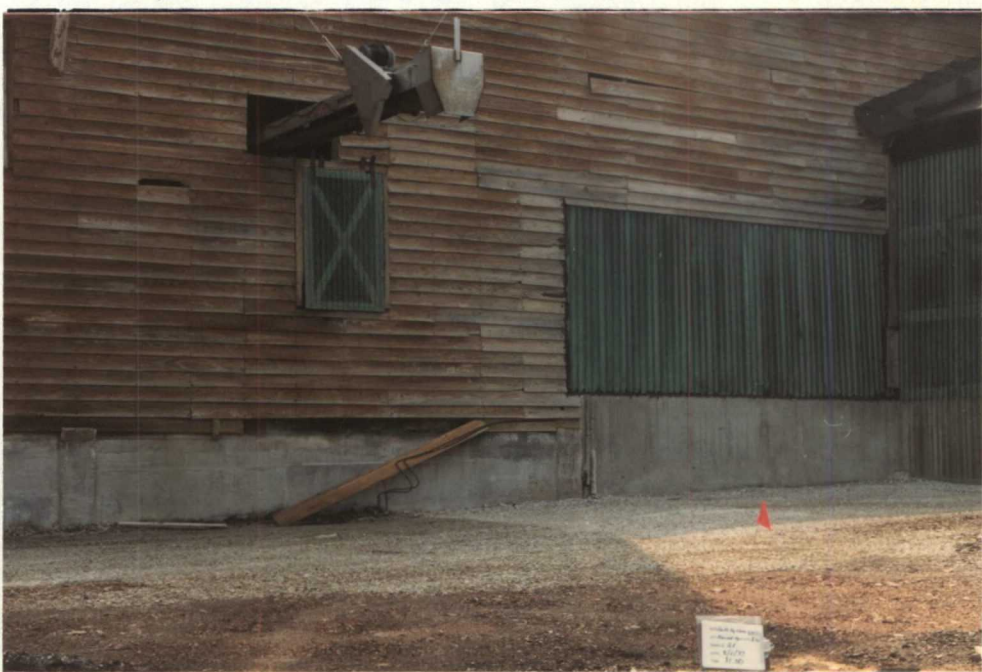
DESCRIPTION: Soil sample 51.

Close-up view.

Perspective view. Composite surface soil sample collected near the hopper loading dock on the north side of the main plant building (1).

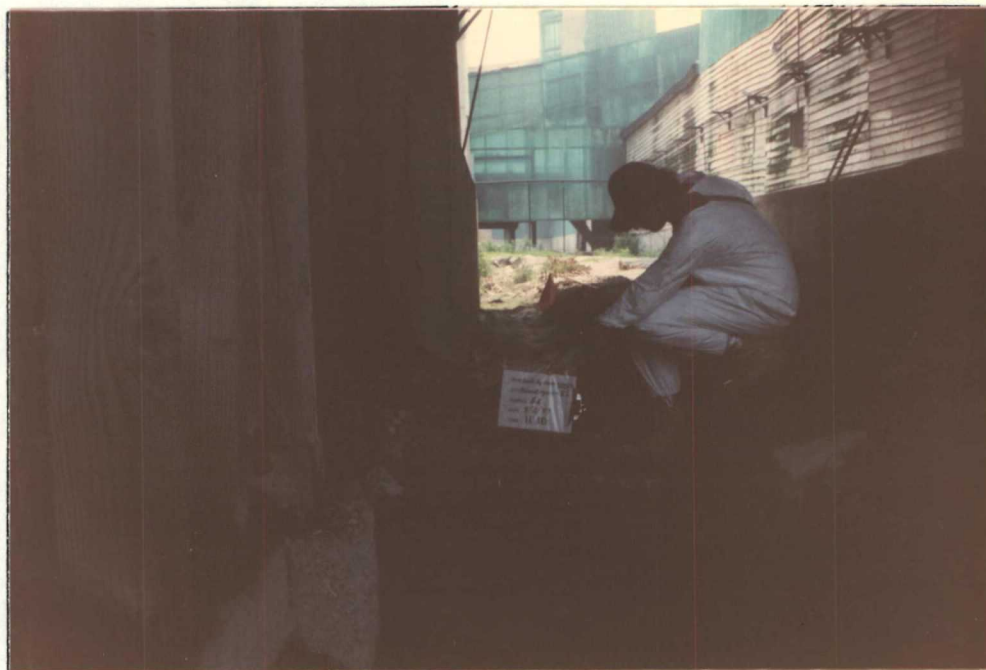
DESCRIPTION: Soil sample 52.

Perspective view. Surface soil sample collected between the
dust suppressant oil tank and the main plant building (1).

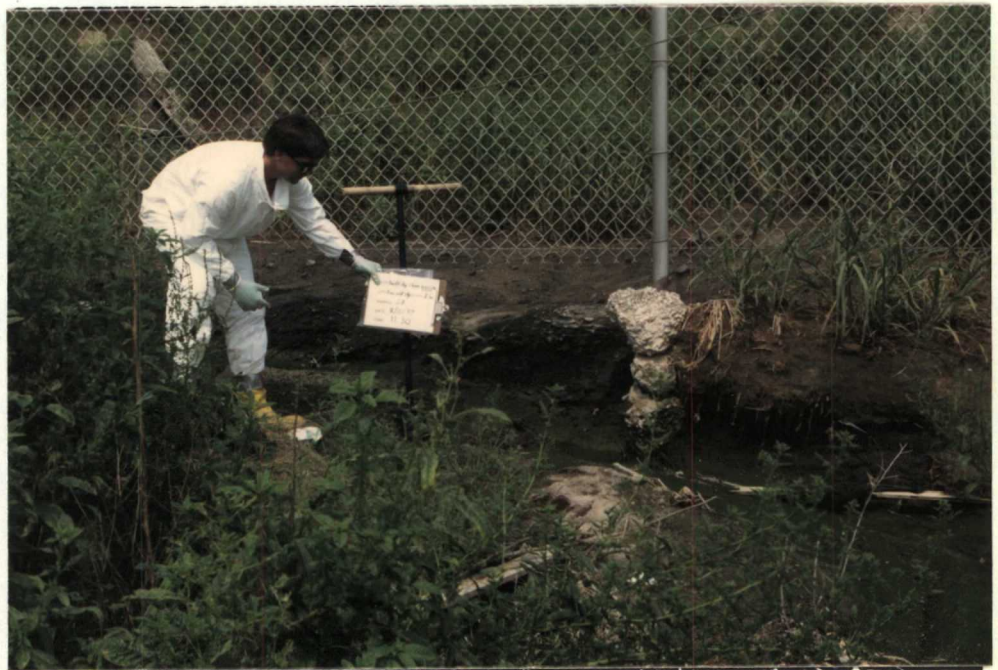
DESCRIPTION: Soil sample S3.
Close-up view.DATE: 8/2/89TIME: 1130DIRECTION OF
PHOTOGRAPH:
NorthwestWEATHER
CONDITIONS:
Sunny, hazy
temp. ~ 90°FPHOTOGRAPHED BY:
Regina BayerSAMPLE ID
(if applicable):
S3

DESCRIPTION: Soil sample S3.
Perspective view. Sediment sample collected from a ditch
near the northwest corner of the site.

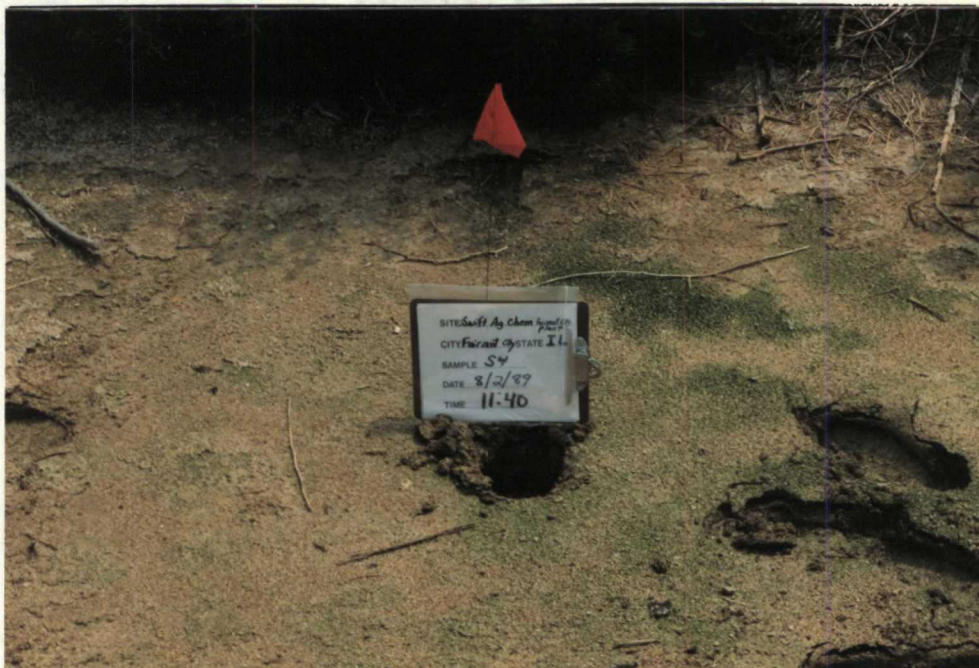
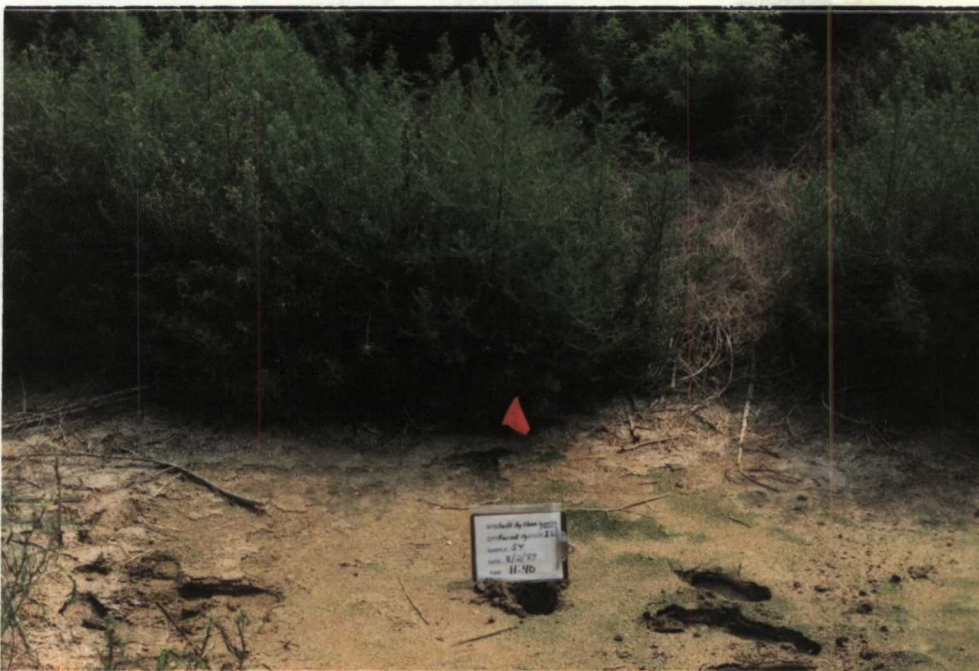
DESCRIPTION: Soil sample 54.Close-up view.DATE: 8/2/89TIME: 1140DIRECTION OF
PHOTOGRAPH:East

DESCRIPTION: Soil sample 54.Perspective view. Surface soil sample collected from within the old reservoir used for deposition of the wet scrubber slurry.

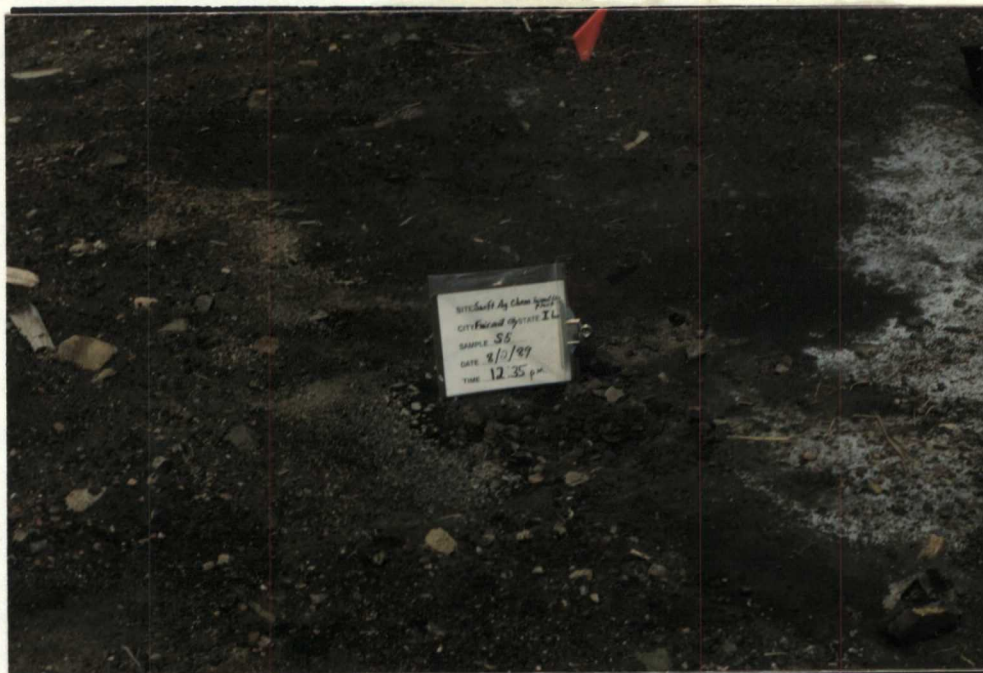
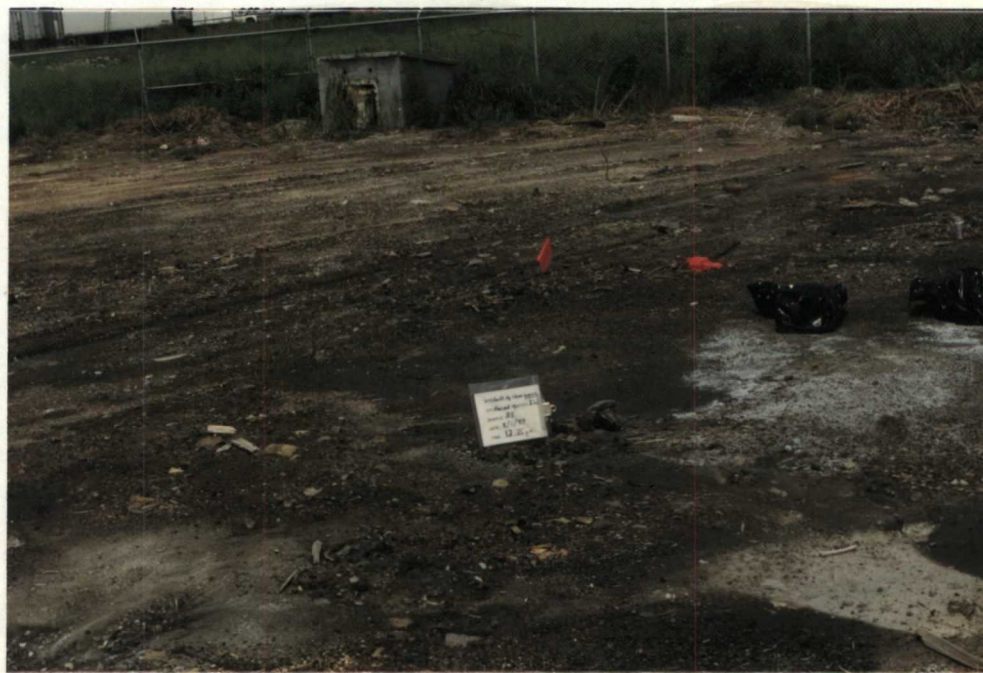
DESCRIPTION: Soil sample 55.

Close-up view.

Perspective view. Surface soil sample collected from the
location of the former settling basin.

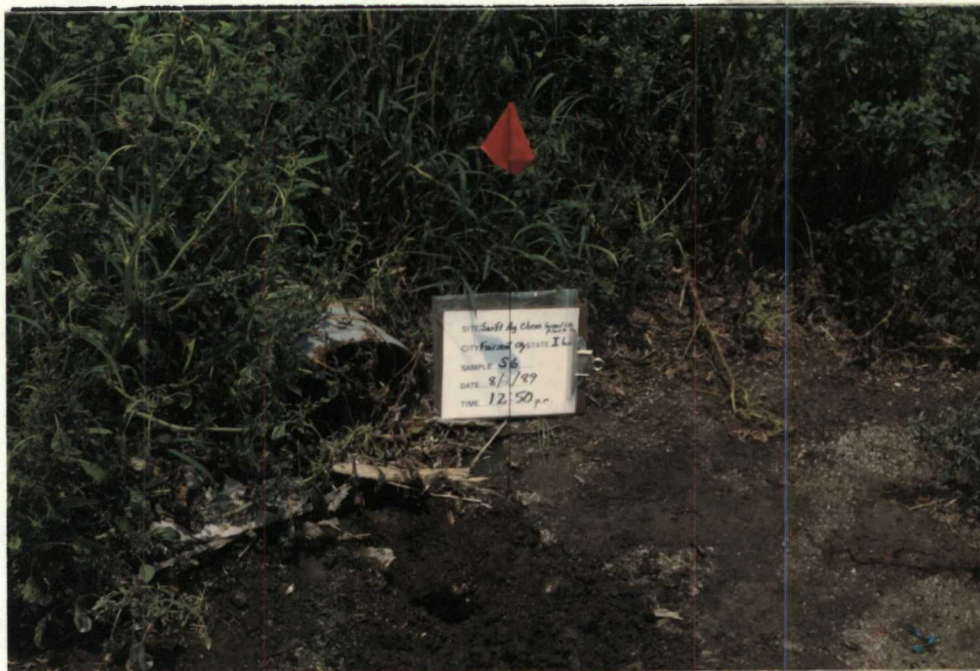
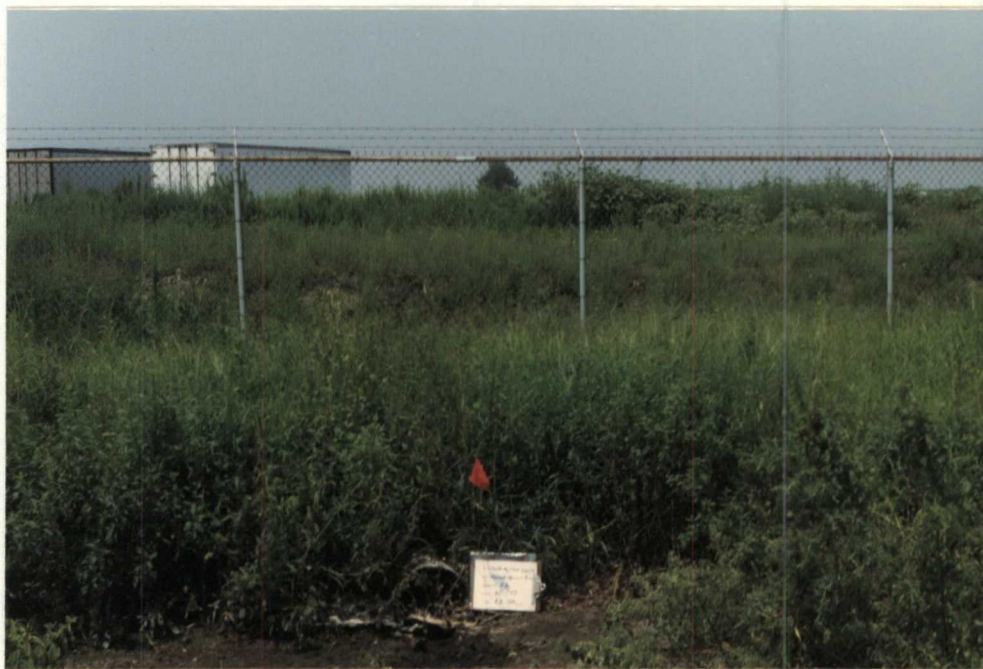
DESCRIPTION: Soil sample 56.

Close-up view.

Perspective view. Sediment sample collected from a
culvert located near the west edge of the site.

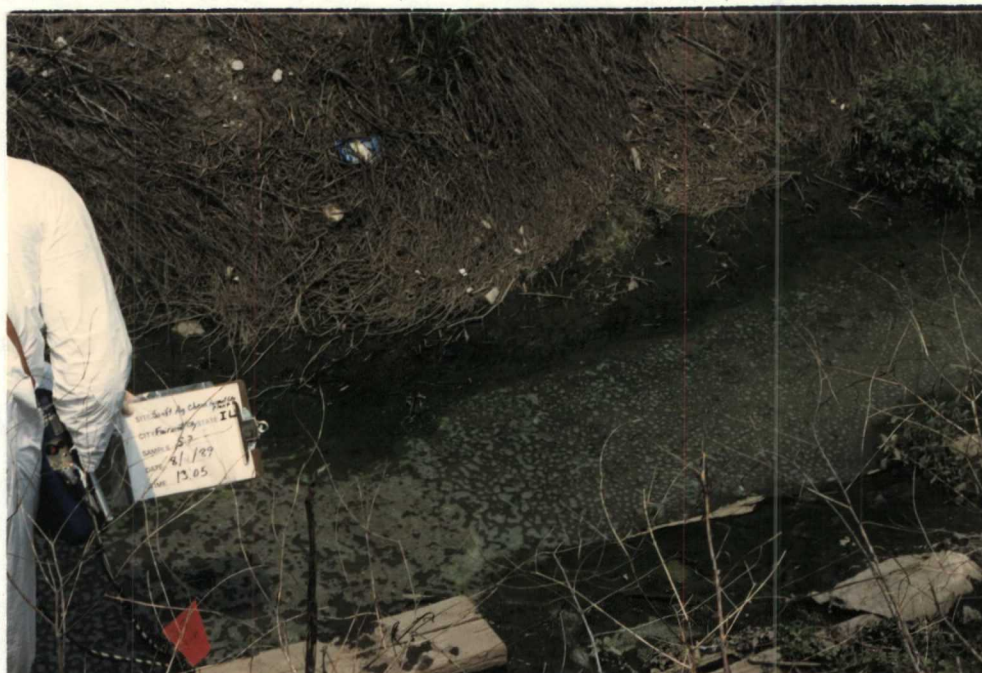
DESCRIPTION: Soil sample 57.
Close-up view.

DESCRIPTION: Soil sample 57.
Perspective view. Sediment sample collected from a ditch
located at the southwest corner of the site prior to its confluence
with a ditch located on the south side of the site.

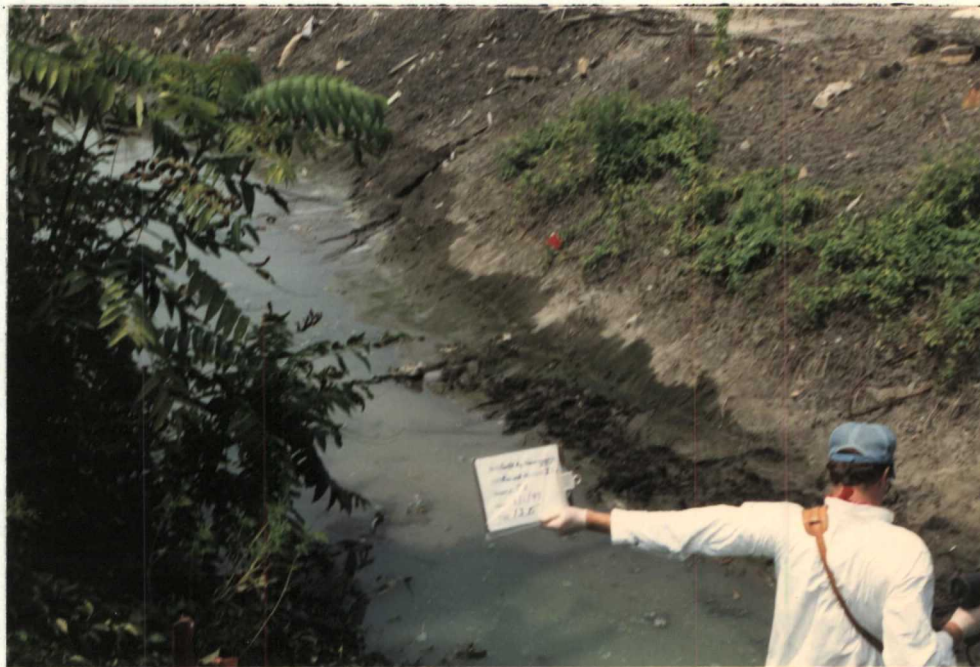
DESCRIPTION: Soil sample SB.

Perspective view. Sediment sample collected from a ditch
located at the southwest corner of the site just after its
confluence with a ditch located on the south side of the plant.

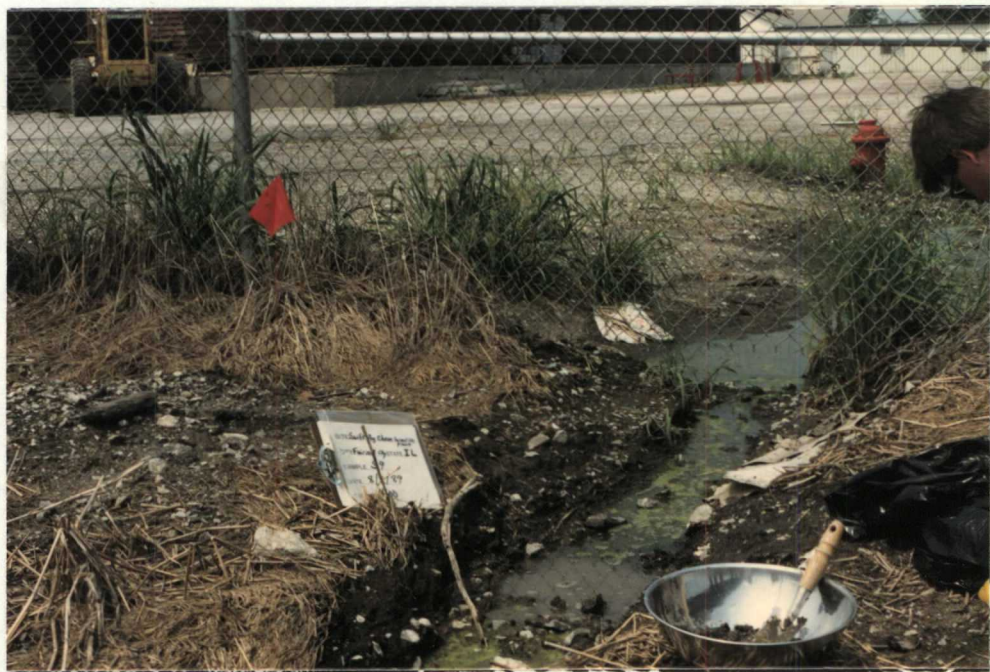
DESCRIPTION: Soil sample 59.Close-up view.DATE: 8/2/89TIME: 1400DIRECTION OF
PHOTOGRAPH:North

DESCRIPTION: Soil sample 59.Perspective view. Sediment sample collected from a ditch located at the southeast corner of the site.

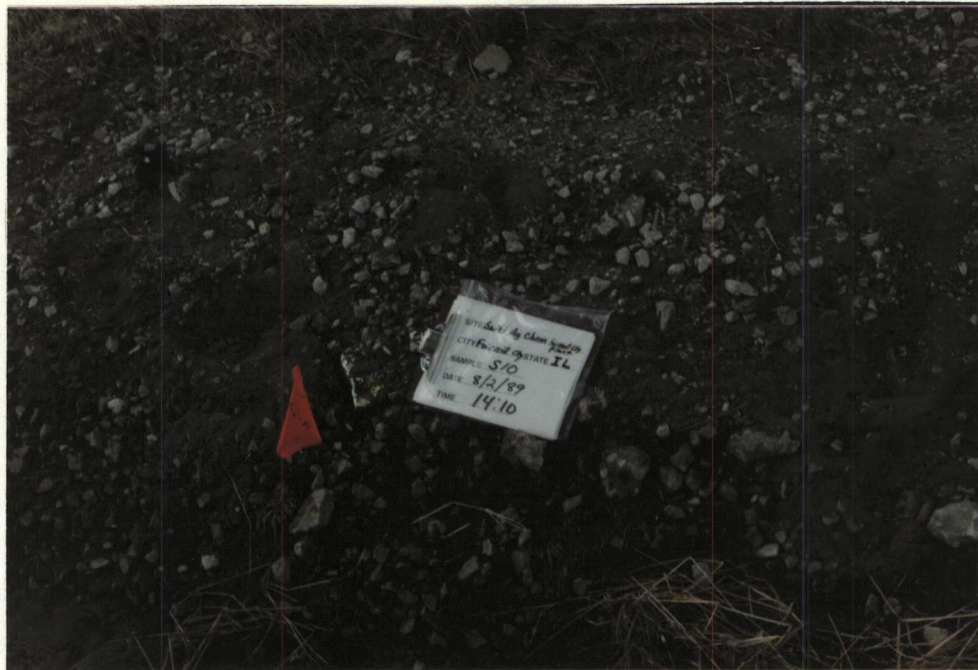
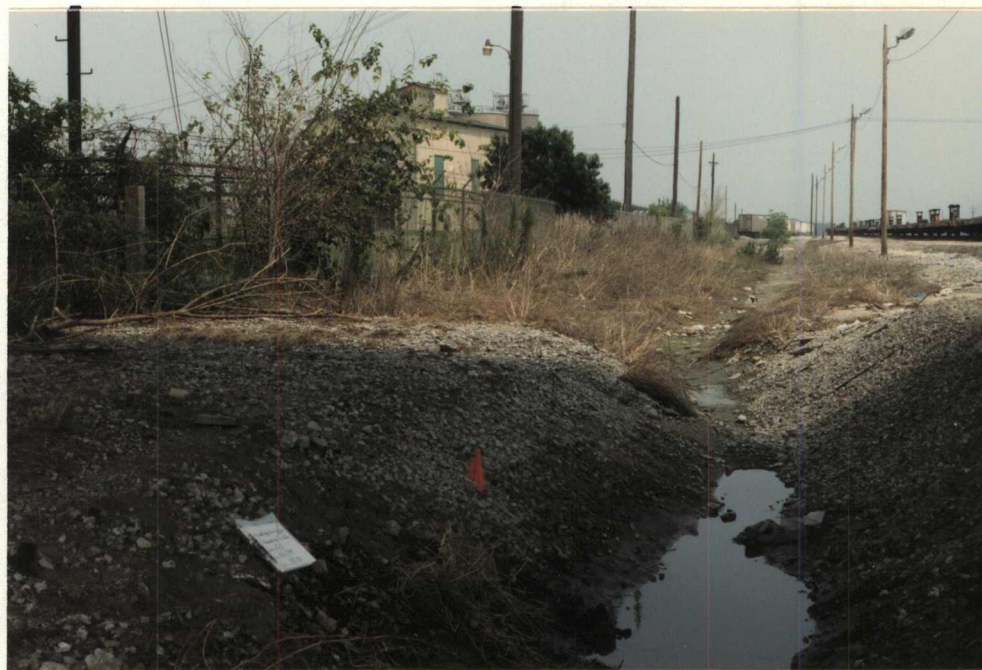
DESCRIPTION: Soil sample S10.

Close-up view.

Perspective view. Sediment sample collected from a ditch
located along the south side of the site, collected prior to
its reaching the east boundary of the site.

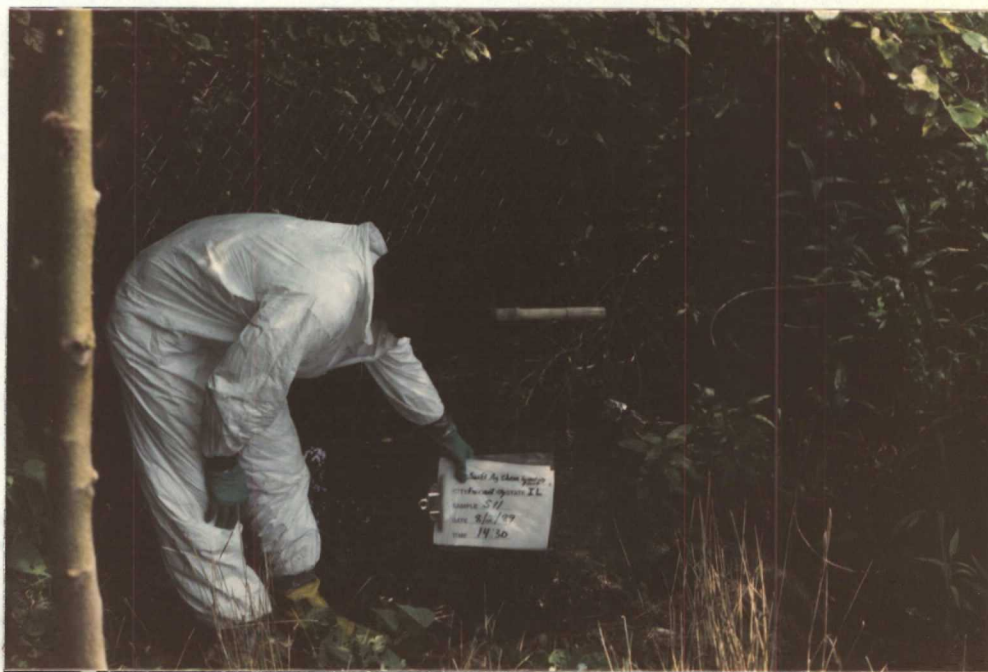
DESCRIPTION: Soil sample S11.
Close-up view.

DESCRIPTION: Soil sample S11.
Perspective view. Sediment sample collected offsite, from a
ditch located on the north side of the site.

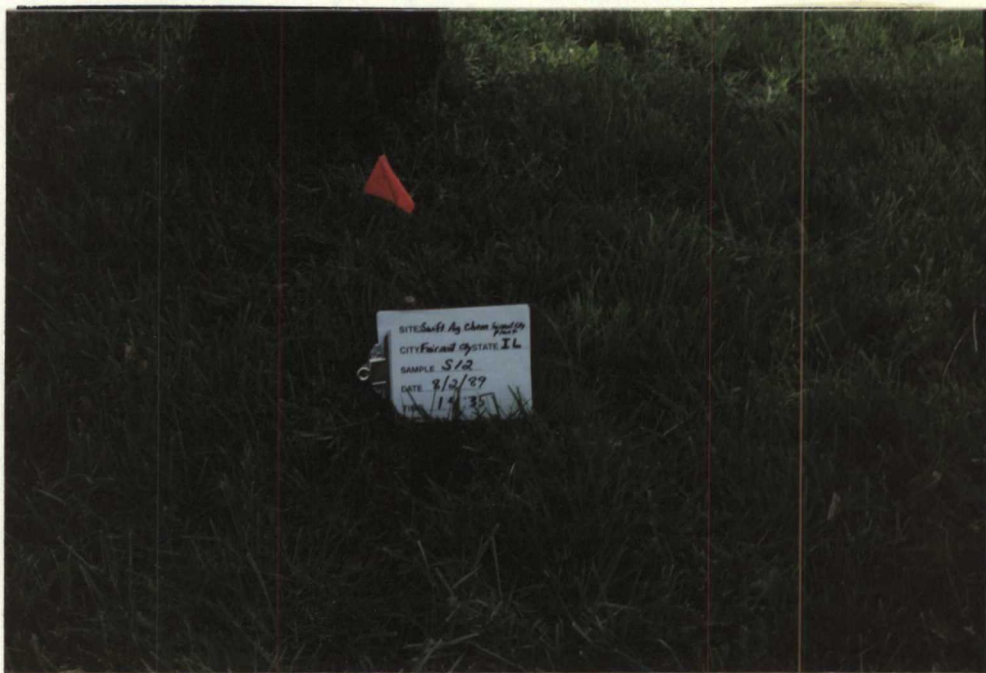
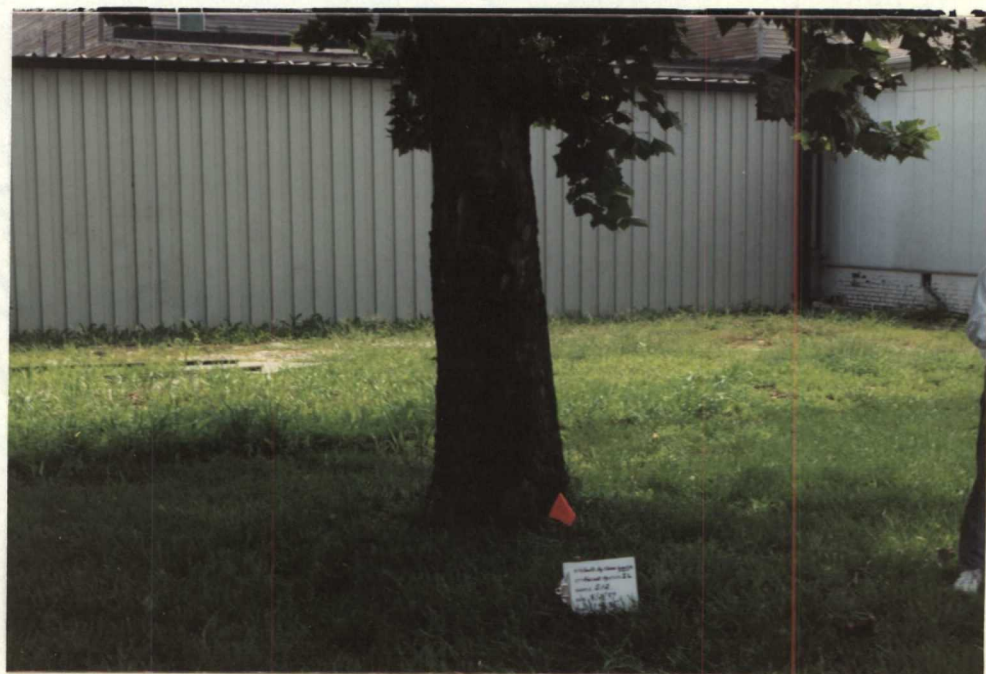
DESCRIPTION: Soil sample 512.
Close-up view.

DESCRIPTION: Soil sample 512.
Perspective view. Surface soil sample collected from the
east side of the site, near the old office building.
